**Flood Control Project Maintenance
Levee Inspections**

Maintenance Issue Types Only, Levee Inspection Report By Mile - Spring 2017

Sutter Maintenance Yard Maintenance Area 0007

Waterway	Bank	Unit Miles	Inspection Start/End	Inspector
Unit No. 01 Feather River	Right	11.90	03/23/2017 03/23/2017	Sterling York

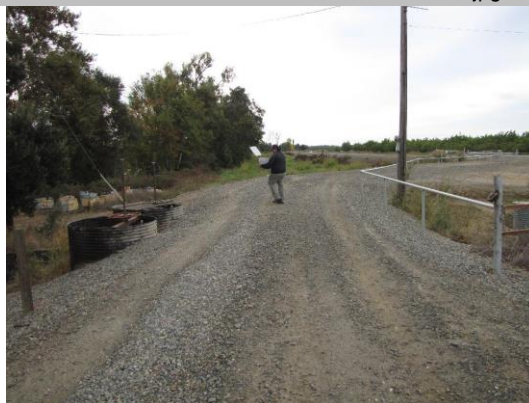
Photo 1 of 3 : UCIP_SP_2017_47836_65814.jpg

View of levee crown looking downstream.

FS_ID:47836
DS_ID:16926
EP_NO: N/A
Repair Type: Non-Urgent
Crossing Status: Found
UCIP Comments: 5/16/2016 Feather River West Levee Improvement Project--Levee currently under construction.6/10/2015 Debris still present in risers and pipes were not replaced with the SBFCA project.12/29/2014 Same as last inspection.5/19/2014 Same as last inspection.11/6/2013 Same as last inspection.5/13/2013 SBFCA project recommends replacing in accordance with title 23.5/7/2013 Same debris issue as last inspection. Recommend repairing top cover to prevent falls. Wheel to open gate chained and locked so could not verify gate operation.10/31/2012 Debris inside riser could prevent slide gate from closing. This crossing was listed in the USACE Periodic Inspections as ID# USACE_CESPK_MA07_2010_a_0060 however, no issues noted. FIELD_STRUCT_DESC: 1 of 2: 60-inch drainage pipe through the levee, 12.5 feet below the crown. Slide gates in 78-inch corrugated metal pipe (CMP) wells on the waterside (WS) slope. Concrete bulkhead on both WS and landside (LS) ends. Reinforced concrete spillway an the WS end. [Additional Reference(s): DWR Levee Log, 2005. USACE Sacramento O&M Manual 152, March 1957 (Station 1+90)]

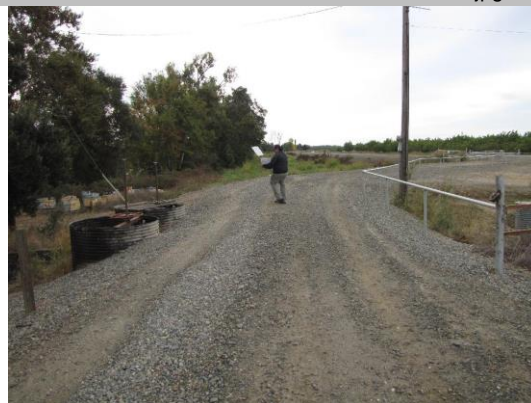
Photo 1 of 3 : UCIP_SP_2017_47837_65820.jpg

FS_ID:47837
DS_ID:17011
EP_NO: N/A
Repair Type: Non-Urgent
Crossing Status: Found
UCIP Comments: 5/16/2016 Feather River West Levee Improvement Project--Levee currently under construction.6/10/2015 Debris still present inside riser and pipe was not replaced with the SBFCA project.12/29/2014 Same as last inspection.5/19/2014 Same as last inspection.11/6/2013 Same as last inspection.5/13/2013 SBFCA project recommends replacing in accordance with title 23.5/7/2013 Same as last inspection. Recommend constructing cover to prevent falls. Wheel to operate gate chained and locked so gate operation could not be verified.10/31/2012 no cover; debris inside riser could prevent slide gate from closing. This crossing was listed in the USACE Periodic Inspections as ID# USACE_CESPK_MA07_2010_a_0060 however, no issues noted. FIELD_STRUCT_DESC: 2 of 2: 60-inch drainage pipe through the levee, 12.5 feet below the crown. Slide gates in 78-inch corrugated metal pipe (CMP) wells on the waterside (WS) slope. Concrete bulkhead on both WS and landside (LS) ends. Reinforced concrete spillway on the WS end. [Additional Reference(s): DWR Levee Log, 2005. USACE Sacramento O&M Manual 152, March 1957 (Station 1+90)]

View of levee crown looking downstream.

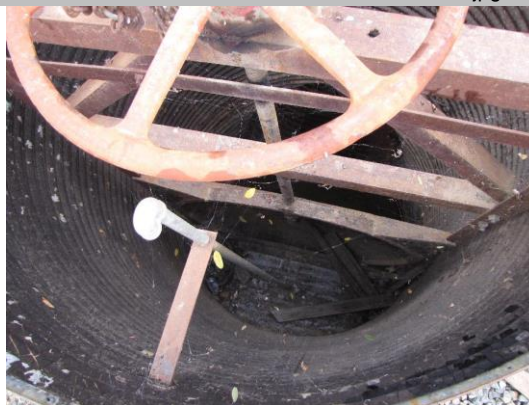
Photo 3 of 3 : UCIP_SP_2017_47837_65818.jpg

78-inch CMP risers located on WS slope. Upstream riser (far left) missing riser cover. Reinforced concrete spillway also located on WS end.

View of crossing behind slide gate.

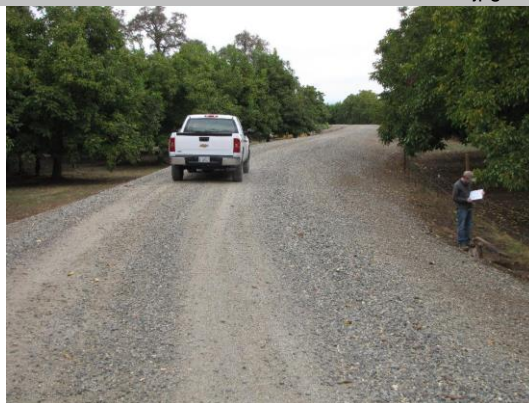
Photo 1 of 3 : UCIP_SP_2017_47975_65825.jpg

FS_ID:47975
DS_ID:16925
EP_NO: 18708
Repair Type: No Action Needed
Crossing Status: Found
UCIP Comments: 5/16/2016 Feather River West Levee Improvement Project--Levee currently under construction. Crossing, referenced as STA 1777+00, will be removed and replaced as indicated in the project Plans for Construction of Feather River West Levee Project, Project Area A, Feather River West Levee Improvement Plans, Sta 1765+00 to 2368+26, Volume 3 of 5.6/10/2015 Pipe appears to be in good condition. No noticeable issues to report.12/29/2014 Same as last inspection.5/19/2014 Same as last inspection.11/6/2013 Same as last inspection.5/13/2013 SBFCA project recommends replacing in accordance with title 23.10/31/2012 WS gate appears to be working. This crossing was listed in the USACE Periodic Inspections as ID# USACE_CESPK_MA07_2010_a_0062 for broken flap gate on WS and half blocked by soil/vegetation on LS.

Overview of levee crown looking upstream.

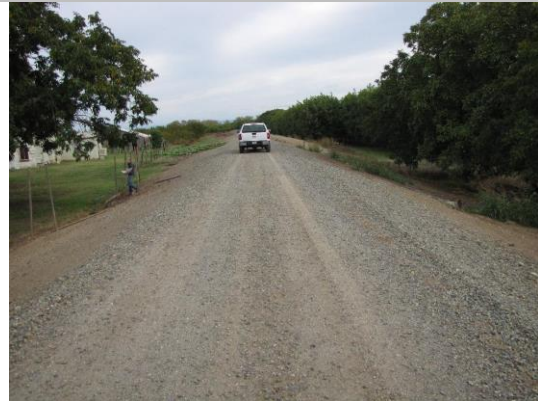
Photo 1 of 3 : UCIP_SP_2017_47976_65833.jpg

FS_ID:47976
DS_ID:16924
EP_NO: 18709
Repair Type: No Action Needed
Crossing Status: Found
UCIP Comments: 5/16/2016 Feather River West Levee Improvement Project--Levee currently under construction. Crossing, referenced as STA 1785+24, will be removed and replaced as indicated in the project Plans for Construction of Feather River West Levee Project, Project Area A, Feather River West Levee Improvement Plans, Sta 1765+00 to 2368+26, Volume 3 of 5.6/10/2015 Pipe appears in good condition. No noticeable issues to report.12/29/2014 Same as last inspection.5/19/2014 Same as last inspection.11/6/2013 Same as last inspection.5/13/2013 SBFCA project recommends replacing in accordance with title 23.5/7/2013 Periodic inspection issue has been resolved and gate is clear to operate normally.10/31/2012 This crossing was listed in the USACE Periodic Inspections as ID# USACE_CESPK_MA07_2010_a_0070 for inoperable flap gate filled with gravel.

FIELD_STRUCT_DESC: 24-inch corrugated metal drainage pipe through the levee, 7 feet below the crown. Flap gate on the waterside (WS) end. Concrete headwall on both WS and landside (LS). Concrete apron located on the WS end. (Permit No. 18709, 2011 - Sandra Waller, permit issued in 2011 to continue the use of existing 24-inch pipe) [Additional Reference(s): DWR Levee Log, 2005. USACE Sacramento O&M Manual 152, March 1957 (Station 19+30)]
FS Date: 5/16/2016 10:23:00 AM

Overview of levee crown looking upstream.

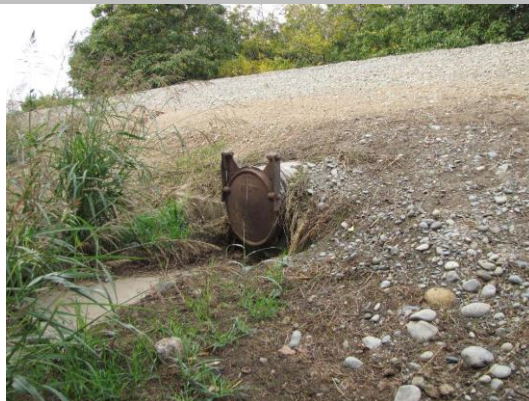
Photo 3 of 3 : UCIP_SP_2017_47976_65831.jpg

View of levee slope at crossing looking downstream.

Comment Code					
Inspector Comment					
FS_ID:47976 DS_ID:16924 EP_NO: 18709 Repair Type: No Action Needed Crossing Status: Found UCIP Comments: 5/16/2016 Feather River West Levee Improvement Project--Levee currently under construction. Crossing, referenced as STA 1785+24, will be removed and replaced as indicated in the project Plans for Construction of Feather River West Levee Project, Project Area A, Feather River West Levee Improvement Plans, Sta 1765+00 to 2368+26, Volume 3 of 5.6/10/2015 Pipe appears in good condition. No noticeable issues to report.12/29/2014 Same as last inspection.5/19/2014 Same as last inspection.11/6/2013 Same as last inspection.5/13/2013 SBFCA project recommends replacing in accordance with title 23.5/7/2013 Periodic inspection issue has been resolved and gate is clear to operate normally.10/31/2012 This crossing was listed in the USACE Periodic Inspections as ID# USACE_CESPK_MA07_2010_a_0070 for inoperable flap gate filled with gravel. FIELD_STRUCT_DESC: 24-inch corrugated metal drainage pipe through the levee, 7 feet below the crown. Flap gate on the waterside (WS) end. Concrete headwall on both WS and landside (LS). Concrete apron located on the WS end. (Permit No. 18709, 2011 - Sandra Waller, permit issued in 2011 to continue the use of existing 24-inch pipe) [Additional Reference(s): DWR Levee Log, 2005. USACE Sacramento O&M Manual 152, March 1957 (Station 19+30)] FS Date: 5/16/2016 10:23:00 AM

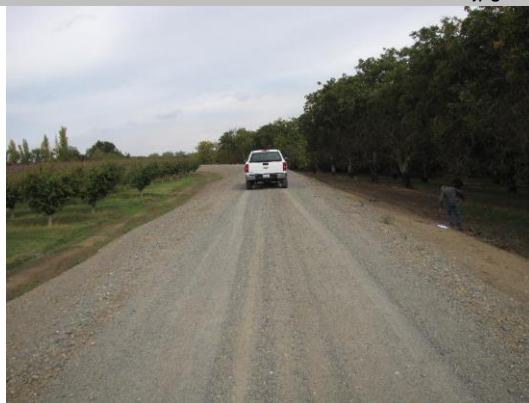
Photo 1 of 3 : UCIP_SP_2017_48000_65849.jpg

FS_ID:48000
DS_ID:16910
EP_NO: N/A
Repair Type: Non-Urgent
Crossing Status: Found
UCIP Comments: 5/16/2016 Feather River West Levee Improvement Project--Levee currently under construction. Crossing, referenced as STA 1809+65, will be removed and replaced as indicated in the project Plans for Construction of Feather River West Levee Project, Project Area A, Feather River West Levee Improvement Plans, Sta 1765+00 to 2368+26, Volume 3 of 5.6/10/2015 Pipe appears in good condition. No noticeable issues to report.12/29/2014 Same as last inspection.5/19/2014 Same as last inspection.11/6/2013 Same as last inspection.5/13/2013 SBFCA project recommends replacing in accordance with title 23.5/7/2013 WS sediment blocking gate has been cleared so gate can operate normally. Recommend clearing sediment buildup at mouth of pipe on LS.10/31/2012 WS headwall may be present not visible due to soil cover. Sediment build up on LS headwall--clear. This crossing was listed in the USACE Periodic Inspections as ID# USACE_CESPK_MA07_2010_a_0083 for inoperable gate.

FIELD_STRUCT_DESC: 24-inch corrugated metal pipe through the levee, 6.7 feet below the crown. Flap gate on the waterside (WS) end. Concrete headwall at both WS and landside (LS) toes. (USACE O&M Manual, 1957) [Additional Reference(s): DWR Levee Log, 2005. USACE Sacramento O&M Manual 152, March 1957 (Station 44+50)]
FS Date: 5/16/2016 10:25:00 AM

View of levee crown looking upstream.

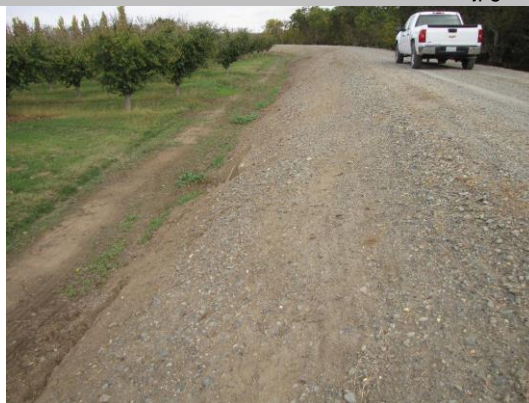
Photo 3 of 3 : UCIP_SP_2017_48000_65851.jpg

View of LS slope.

Comment Code					
Inspector Comment					
FS_ID:48000 DS_ID:16910 EP_NO: N/A Repair Type: Non-Urgent Crossing Status: Found UCIP Comments: 5/16/2016 Feather River West Levee Improvement Project--Levee currently under construction. Crossing, referenced as STA 1809+65, will be removed and replaced as indicated in the project Plans for Construction of Feather River West Levee Project, Project Area A, Feather River West Levee Improvement Plans, Sta 1765+00 to 2368+26, Volume 3 of 5.6/10/2015 Pipe appears in good condition. No noticeable issues to report.12/29/2014 Same as last inspection.5/19/2014 Same as last inspection.11/6/2013 Same as last inspection.5/13/2013 SBFCA project recommends replacing in accordance with title 23.5/7/2013 WS sediment blocking gate has been cleared so gate can operate normally. Recommend clearing sediment buildup at mouth of pipe on LS.10/31/2012 WS headwall may be present not visible due to soil cover. Sediment build up on LS headwall--clear. This crossing was listed in the USACE Periodic Inspections as ID# USACE_CESPK_MA07_2010_a_0083 for inoperable gate. FIELD_STRUCT_DESC: 24-inch corrugated metal pipe through the levee, 6.7 feet below the crown. Flap gate on the waterside (WS) end. Concrete headwall at both WS and landside (LS) toes. (USACE O&M Manual, 1957) [Additional Reference(s): DWR Levee Log, 2005. USACE Sacramento O&M Manual 152, March 1957 (Station 44+50)] FS Date: 5/16/2016 10:25:00 AM

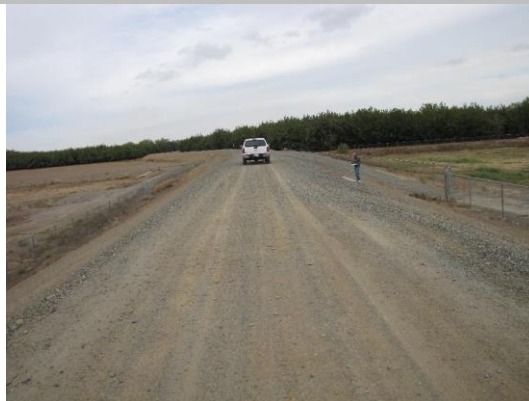
Photo 1 of 3 : UCIP_SP_2017_49199_65855.jpg

FS_ID:49199
DS_ID:16921
EP_NO: N/A
Repair Type: Non-Urgent
Crossing Status: Found
UCIP Comments: 5/16/2016 Feather River West Levee Improvement Project--Levee currently under construction. Crossing, referenced as STA 1818+72, will be removed and replaced with a 36-inch pipe as indicated in the project Plans for Construction of Feather River West Levee Project, Project Area A, Feather River West Levee Improvement Plans, Sta 1765+00 to 2368+26, Volume 3 of 5.6/10/2015 Riser is still damaged and cant locate signs of pipe on LS.12/29/2014 Same as last inspection.5/19/2014 Same as last inspection.11/6/2013 Same as last inspection.5/13/2013 SBFCA project recommends relacing in accordance with title 23.5/7/2013 Same as last inspection, rodent activity near crossing, need to repair rodent hole on WS.10/31/2012 CMP riser damage-repair needed. Unable to locate pipe on LS. This crossing was listed in the USACE Periodic Inspections as ID# USACE_CESPK_MA07_2010_a_0090 however, no issues noted.

Overview of levee crown looking upstream.

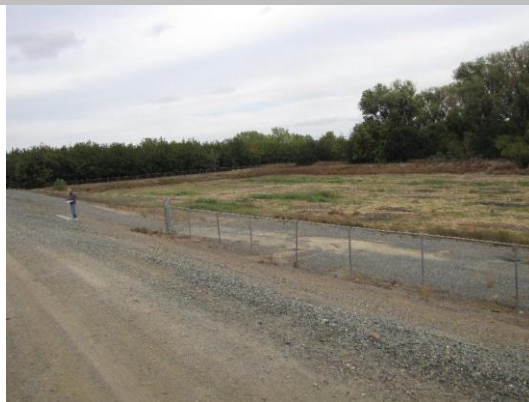
Photo 2 of 3 : UCIP_SP_2017_49199_65854.jpg

View of WS slope looking upstream. Matt is standing near CMP riser.

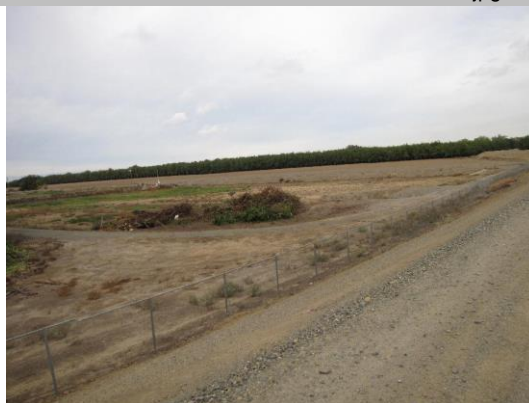
Photo 3 of 3 : UCIP_SP_2017_49199_65853.jpg

FIELD_STRUCT_DESC: 24-inch corrugated metal drainage pipe through the levee, 25.5 feet below the crown. Slide gate in 36-inch corrugated metal pipe (CMP) riser on the waterside (WS) slope.
[Additional Reference(s): DWR Levee Log, 2005. USACE Sacramento O&M Manual 152, March 1957 (Station 52+50)]
FS Date: 5/16/2016 10:25:00 AM

View of LS.

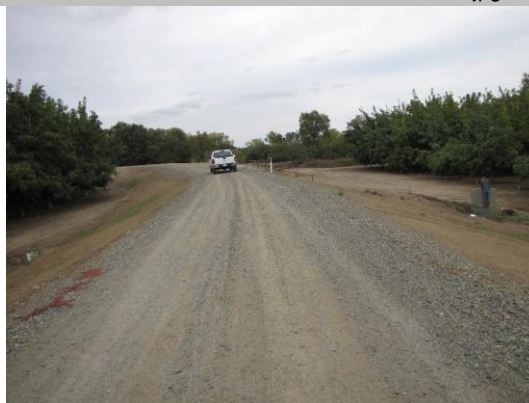
Photo 1 of 3 : UCIP_SP_2017_47981_65872.jpg

FS_ID:47981
DS_ID:16918
EP_NO: N/A
Repair Type: Non-Urgent
Crossing Status: Found
UCIP Comments: 5/16/2016 Feather River West Levee Improvement Project--Levee currently under construction. 12-inch and 24-inch crossings, referenced as STA 1834+42, will be removed and replaced with a 36-inch pipe as indicated in the project Plans for Construction of Feather River West Levee Project, Project Area A, Feather River West Levee Improvement Plans, Sta 1765+00 to 2368+26, Volume 3 of 5.6/10/2015 Same as last inspection.12/29/2014 Same as last inspection.5/19/2014 Same as last inspection.11/6/2013 Same as last inspection.5/13/2013 SBFCA project recommends relacing in accordance with title 23.5/7/2013 Structure does appear to be altered. Contact Levee Inspector to pursue NOV.10/31/2012 Unable to determine if this crossing has been altered, will need to coordinate with levee inspector. This crossing was listed in the USACE Periodic Inspection as ID# USACE_CESPK_MA07_2010_a_0104 however, no issues reported.

FIELD_STRUCT_DESC: 12-inch steel drainage pipe sleeved through existing 24-inch pipe. The 24-inch corrugated metal pipe goes through the levee at approximately 15.3 feet below the crown. Flap gate inside riser on the WS end. A reinforced concrete pipe riser located on the waterside (WS). [Additional Reference(s): DWR Levee Log, 2005. USACE Sacramento O&M Manual 152, March 1957 (Station 69+00)]
FS Date: 5/16/2016 10:26:00 AM

View of levee crown looking upstream at crossing.

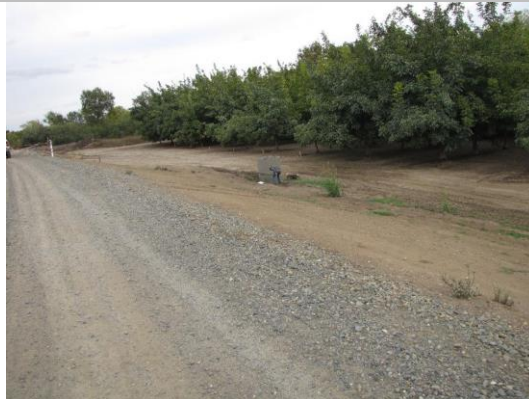
Photo 2 of 3 : UCIP_SP_2017_47981_65871.jpg

View of WS looking at crossing.

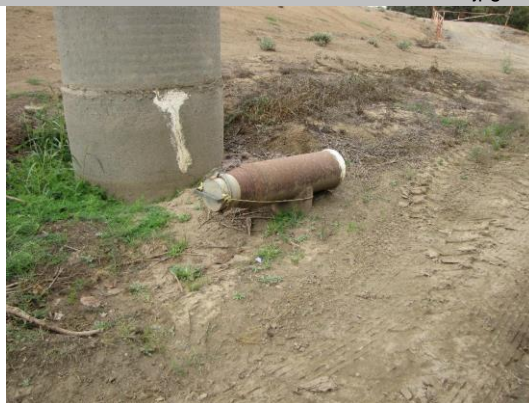
Photo 3 of 3 : UCIP_SP_2017_47981_65875.jpg

View of additional appurtances associated with crossing.

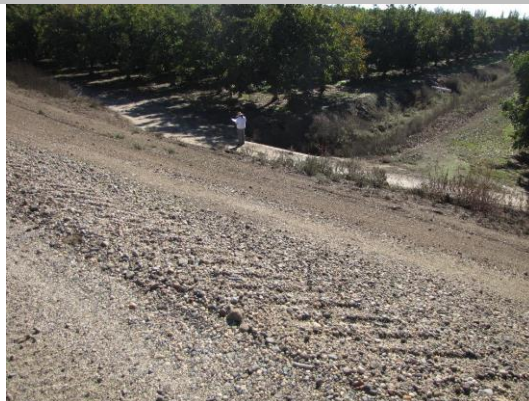
Photo 1 of 3 : UCIP_SP_2017_48005_65904.jpg

FIELD_STRUCT_DESC: 1 of 2: 60-inch corrugated metal drainage pipe (downstream pipe) through the levee, 23.4 feet below the crown. Concrete headwalls on both the waterside (WS) and landside (LS) ends. Flap gate on the WS end. Ditch at WS outlet. [Additional Reference(s): DWR Levee Log, 2005. USACE Sacramento O&M Manual 152, March 1957 (Station 195+80)]
FS Date: 5/16/2016 10:29:00 AM

View of WS. Concrete headwall located at levee toe.

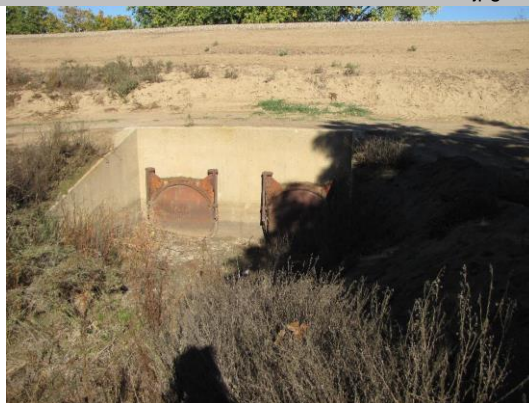
Photo 2 of 3 : UCIP_SP_2017_48006_65910.jpg

View of headwall and flap gates located on WS.

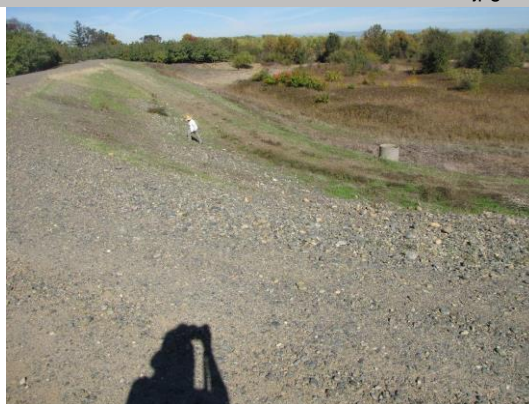
Photo 2 of 3 : UCIP_SP_2017_47991_65956.jpg

View of WS looking upstream at slope and concrete standpipe.

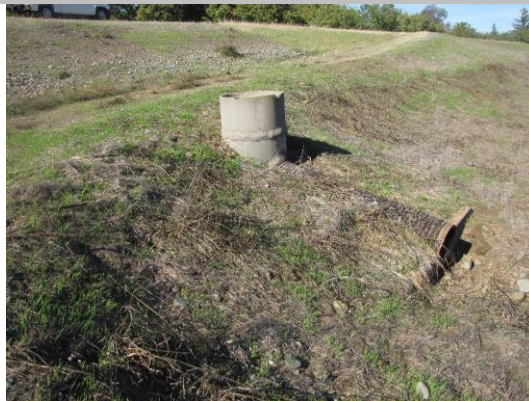
Photo 3 of 3 : UCIP_SP_2017_47991_65955.jpg

View of concrete standpipe located on WS.

Comment Code					
Inspector Comment					
FS_ID:47991 DS_ID:16933 EP_NO: N/A Repair Type: Non-Urgent Crossing Status: Found UCIP Comments: 5/16/2016 Feather River West Levee Improvement Project--Levee currently under construction. Crossing, referenced as STA 2239+66, will be removed as indicated in the project Plans for Construction of Feather River West Levee Project, Project Area A, Feather River West Levee Improvement Plans, Sta 1765+00 to 2368+26, Volume 3 of 5.6/11/2015 Still unable to find anything on the LS. SBFCA project recommends removal.12/30/2014 Same as last inspection.5/20/2014 Same as last inspection.11/7/2013 Same as last inspection.5/13/2013 SBFCA project recommends removal.5/10/2013 Same as last inspection.11/5/2012 nothing found on LS-residential; no headwall found on LS--has it been buried? Need to investigate if crossing is here. This crossing was listed in the USACE Periodic Inspection as ID# USACE_CESPK_MA07_2010_a_0314 no issues reported. FIELD_STRUCT_DESC: 24-inch corrugated metal drainage pipe through the levee, 14.5 feet below the crown. Concrete headwall at both waterside (WS) and landside (LS) toes. Flap gate in 36-inch concrete standpipe on the berm. [Additional Reference(s): DWR Levee Log, 2005. USACE Sacramento O&M Manual 152, March 1957 (Station 471+26)] FS Date: 5/16/2016 10:33:00 AM

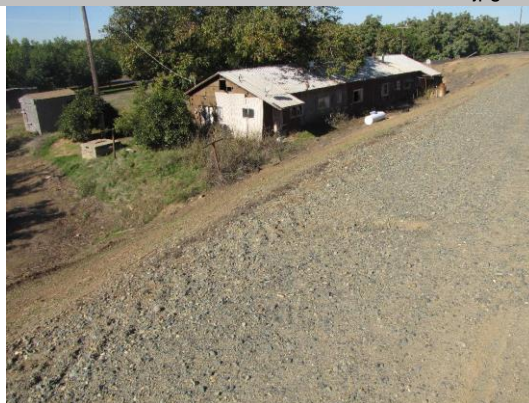
Photo 1 of 3 : UCIP_SP_2017_47958_65974.jpg

View of LS looking upstream at crossing.

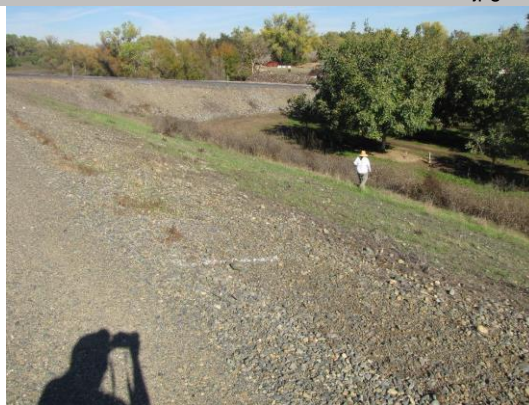
Photo 2 of 3 : UCIP_SP_2017_47958_65973.jpg

View of WS looking upstream at crossing.

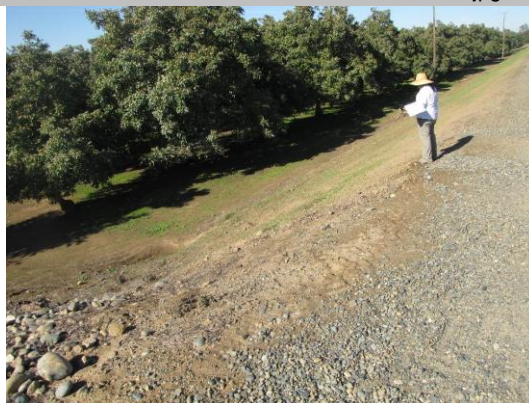
Photo 1 of 3 : UCIP_SP_2017_47994_65979.jpg

View of LS looking upstream at crossing.

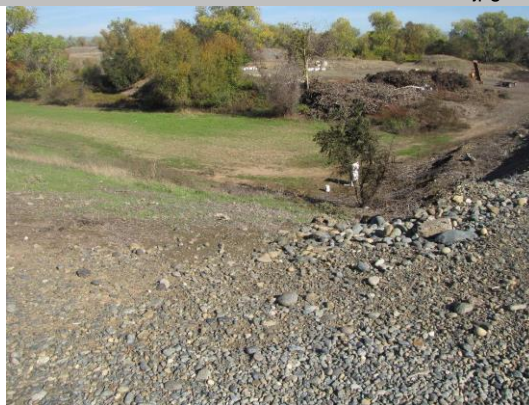
Photo 2 of 3 : UCIP_SP_2017_47994_65978.jpg

View of WS looking upstream at crossing.

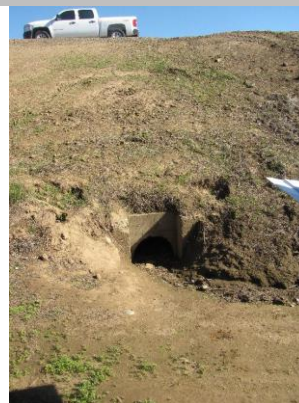
Photo 3 of 3 : UCIP_SP_2017_47994_65982.jpg

View of inlet located on LS.

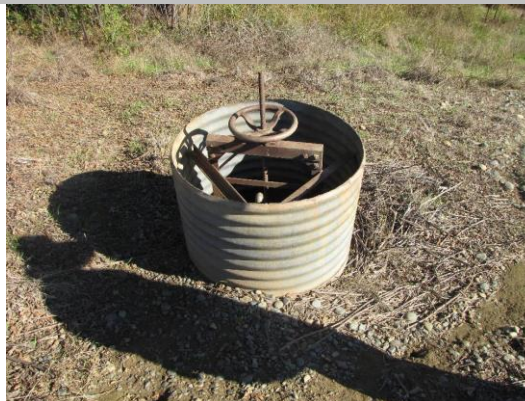
Photo 3 of 3 : UCIP_SP_2017_48009_65992.jpg

LM Start	11.35	Rating **	M	Issue No.	103 (cont)
LM End	11.35	Issue Type +	Ma	Location *	CR
Category	Supplemental			GPS Latitude/Longitude	
				Start	End
Item	DWR UCIP LMA Responsibility			39.435497 °	39.435497 °
				-121.645712 °	-121.645712 °
DWR ID

CMP riser located on WS slope.

Comment Code					
Inspector Comment					
FS_ID:48009 DS_ID:16936 EP_NO: N/A Repair Type: Non-Urgent Crossing Status: Found UCIP Comments: 5/16/2016 Feather River West Levee Improvement Project--Levee currently under construction. Crossing, referenced as STA 2274+86, will be removed as indicated in the project Plans for Construction of Feather River West Levee Project, Project Area A, Feather River West Levee Improvement Plans, Sta 1765+00 to 2368+26, Volume 3 of 5.6/11/2015 LS inlet is still mostly buried with soil. SBFCA project recommends removal.12/30/2014 Same as last inspection.5/20/2014 Same as last inspection.5/13/2013 SBFCA project recommends removal.5/10/2013 Same as last inspection. LS inlet excavated but more than 50% still covered by soil.11/7/2013 Same as last inspection.11/5/2012 Non-fuctional crossing LS inlet buried; WS-debris in CMP riser, riser missing lid; This crossing was listed in the USACE Periodic Inspection as ID# USACE_CESPK_MA07_2010_a_0344 for pipes filled > 50 % with soil. FIELD_STRUCT_DESC: 24-inch corrugated metal drainage pipe through the levee, 16.2 feet below the crown. Concrete headwall at both waterside (WS) and landside (LS) toes. Flap gate on the WS end. [Additional Reference(s): DWR Levee Log, 2005. USACE Sacramento O&M Manual 152, March 1957 (Station 508+40)] FS Date: 5/16/2016 10:57:00 AM
